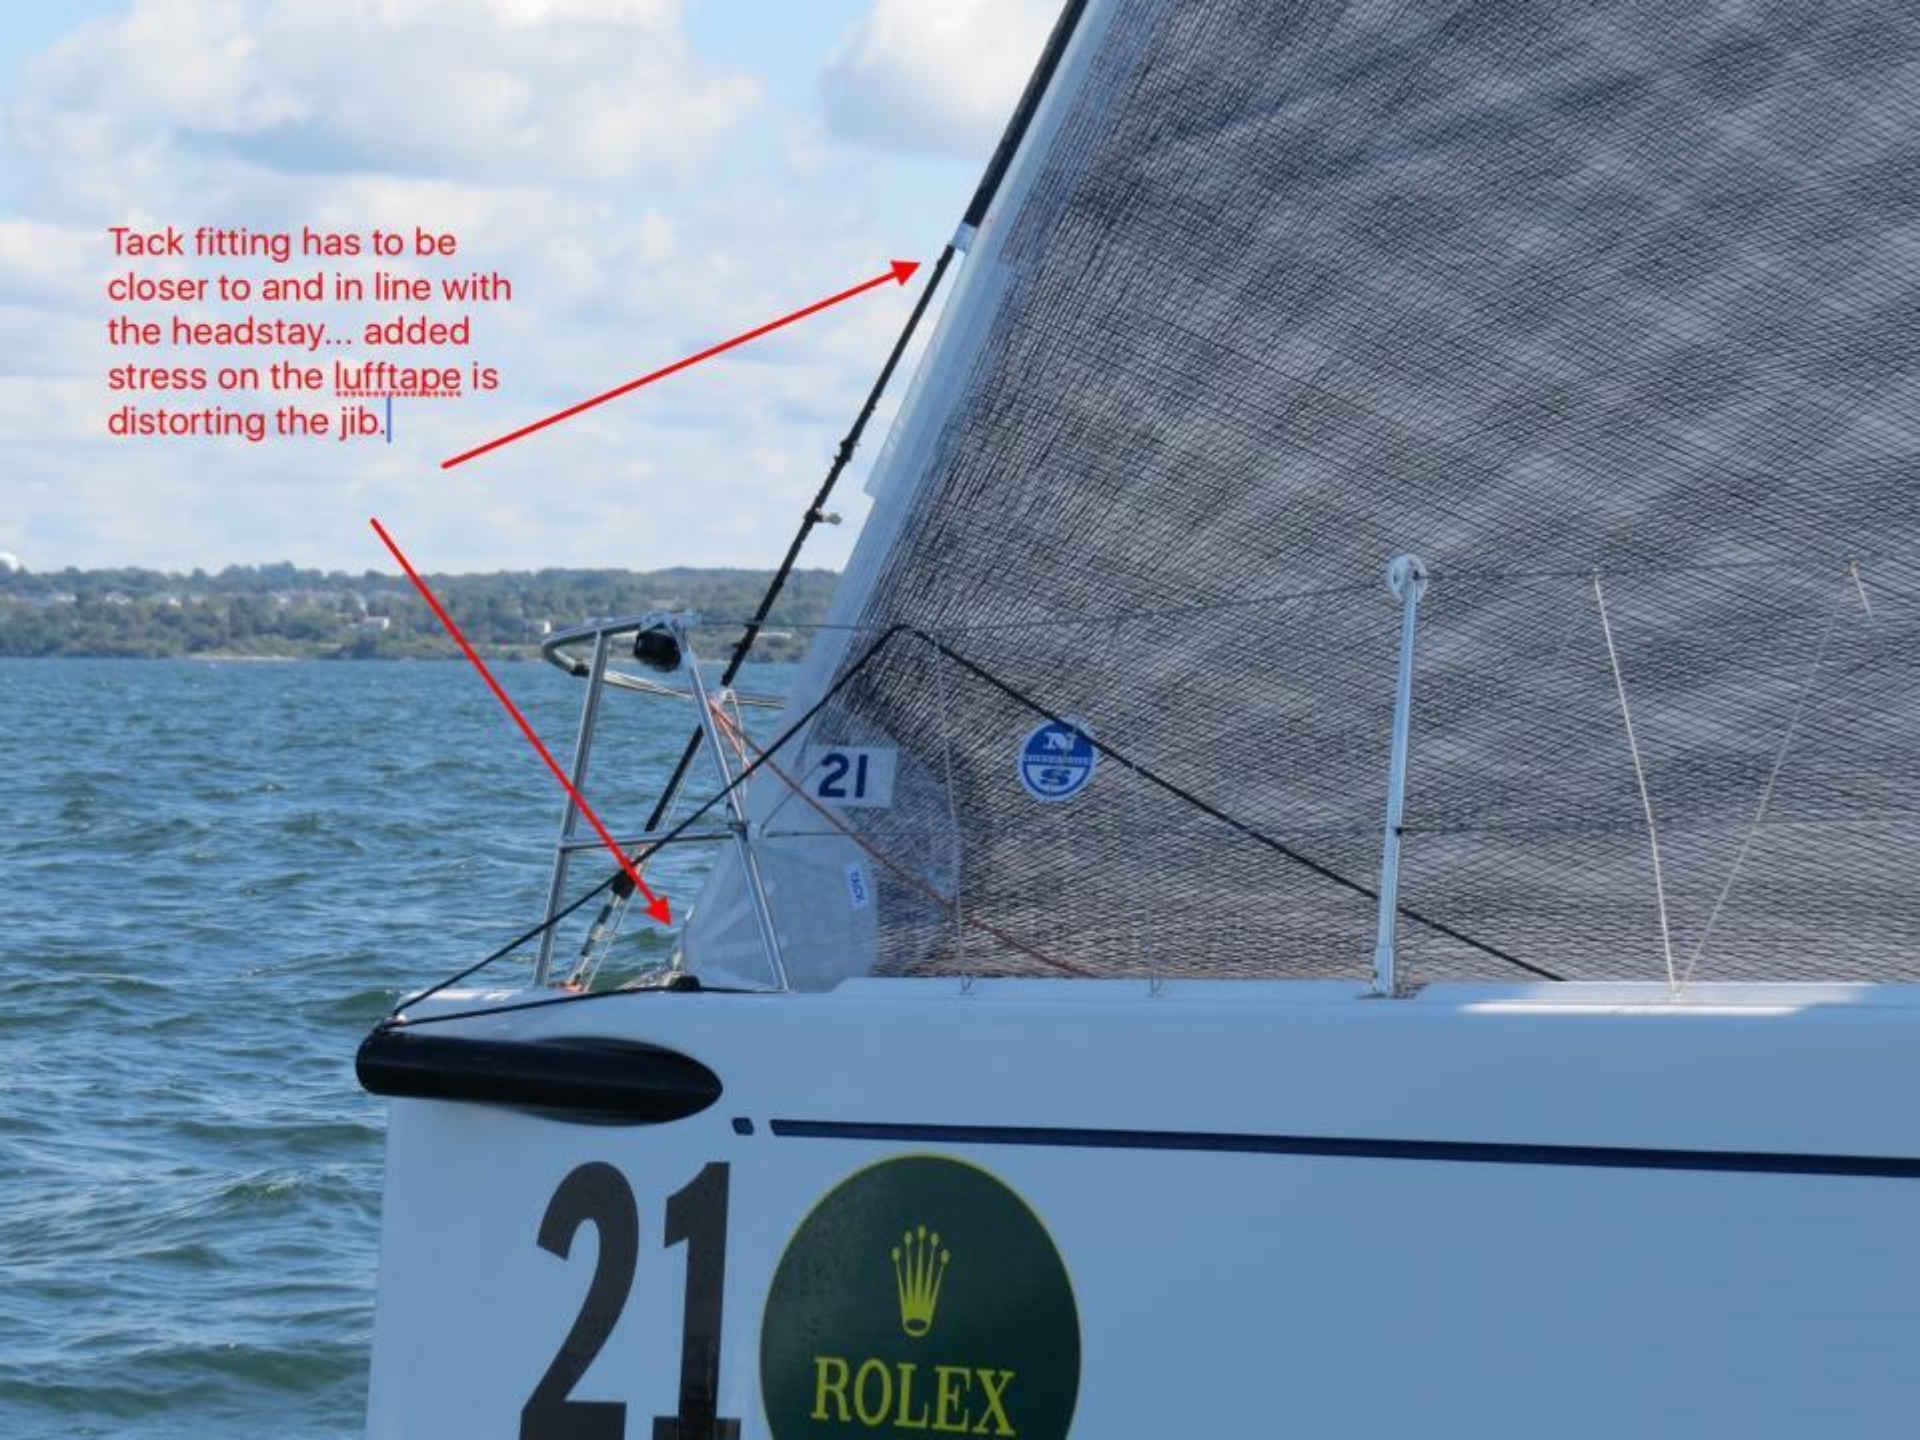
Tack fitting has to be closer to and in line with the headstay... added stress on the lufftape is distorting the jib.

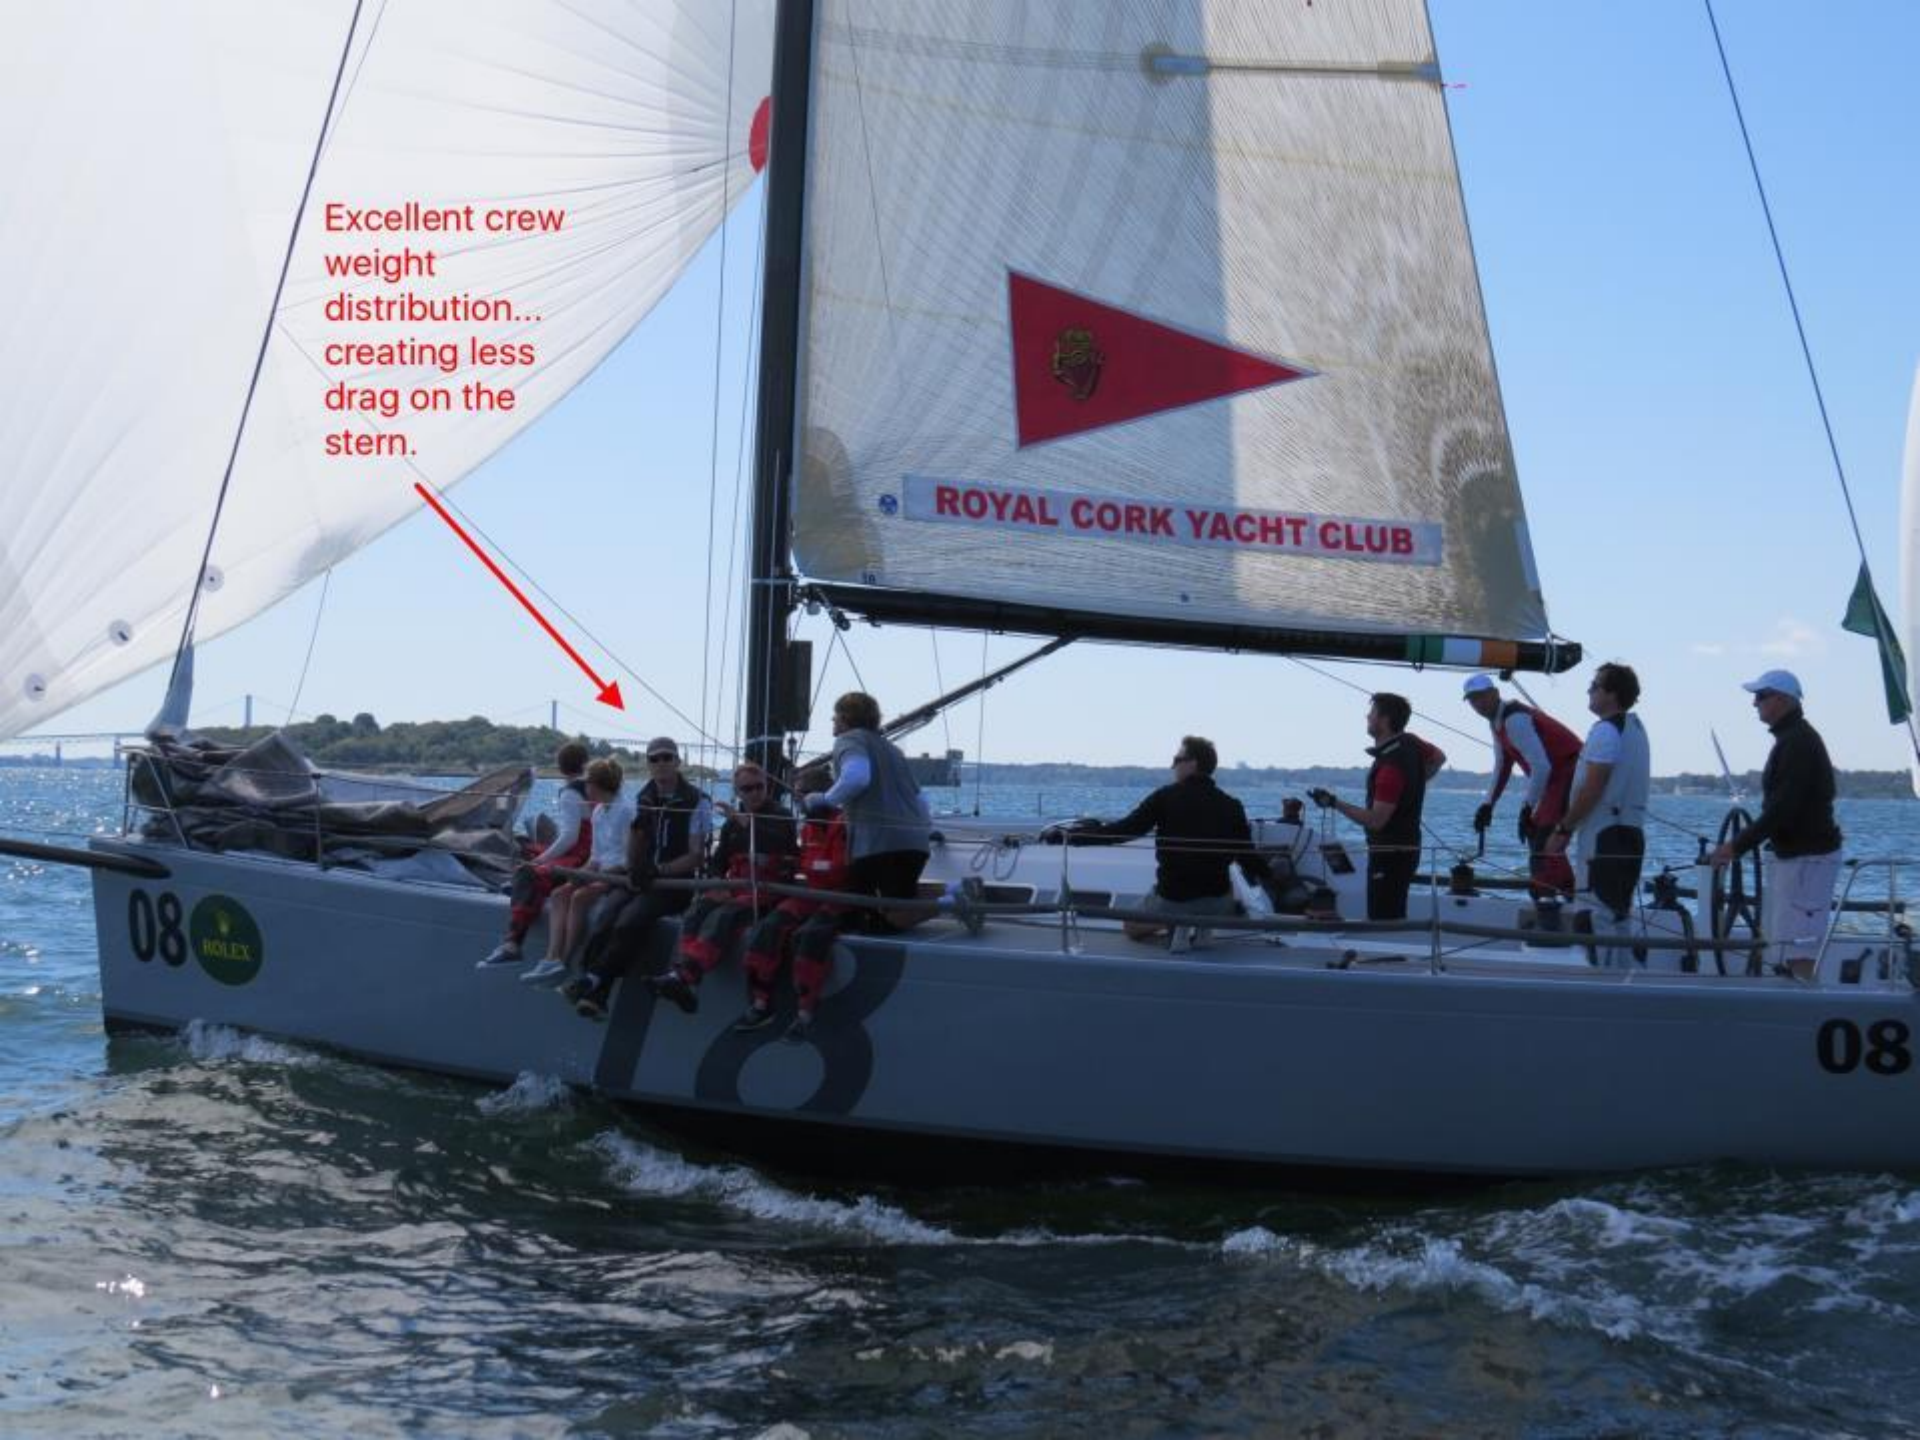
Excellent crew
weight
distribution...
creating less
drag on the
stern.

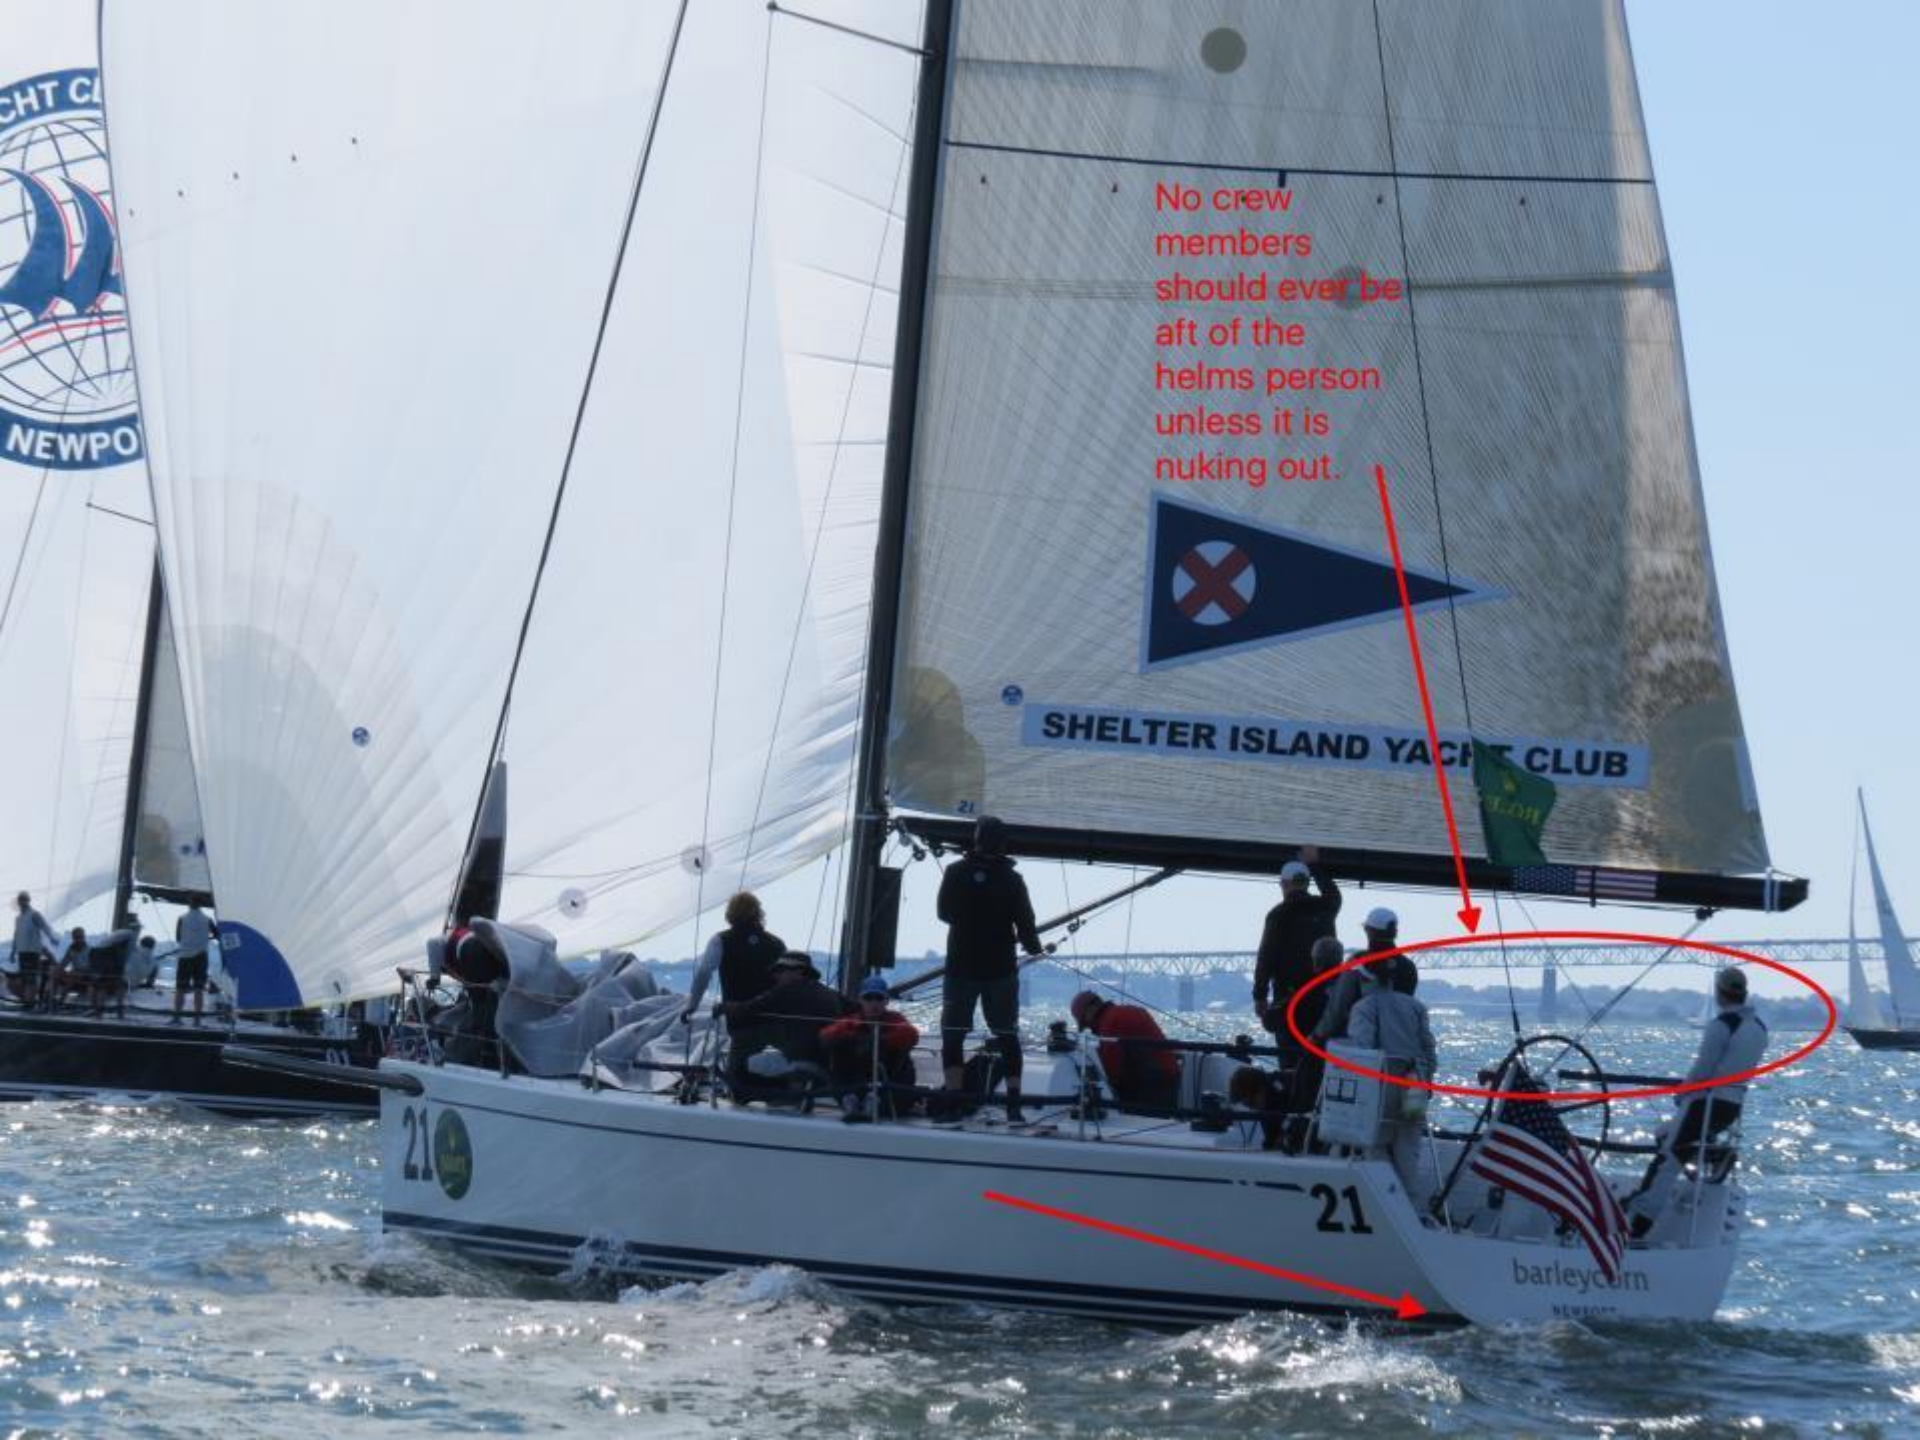
No crew members should ever be aft of the helms person unless it is niking out.

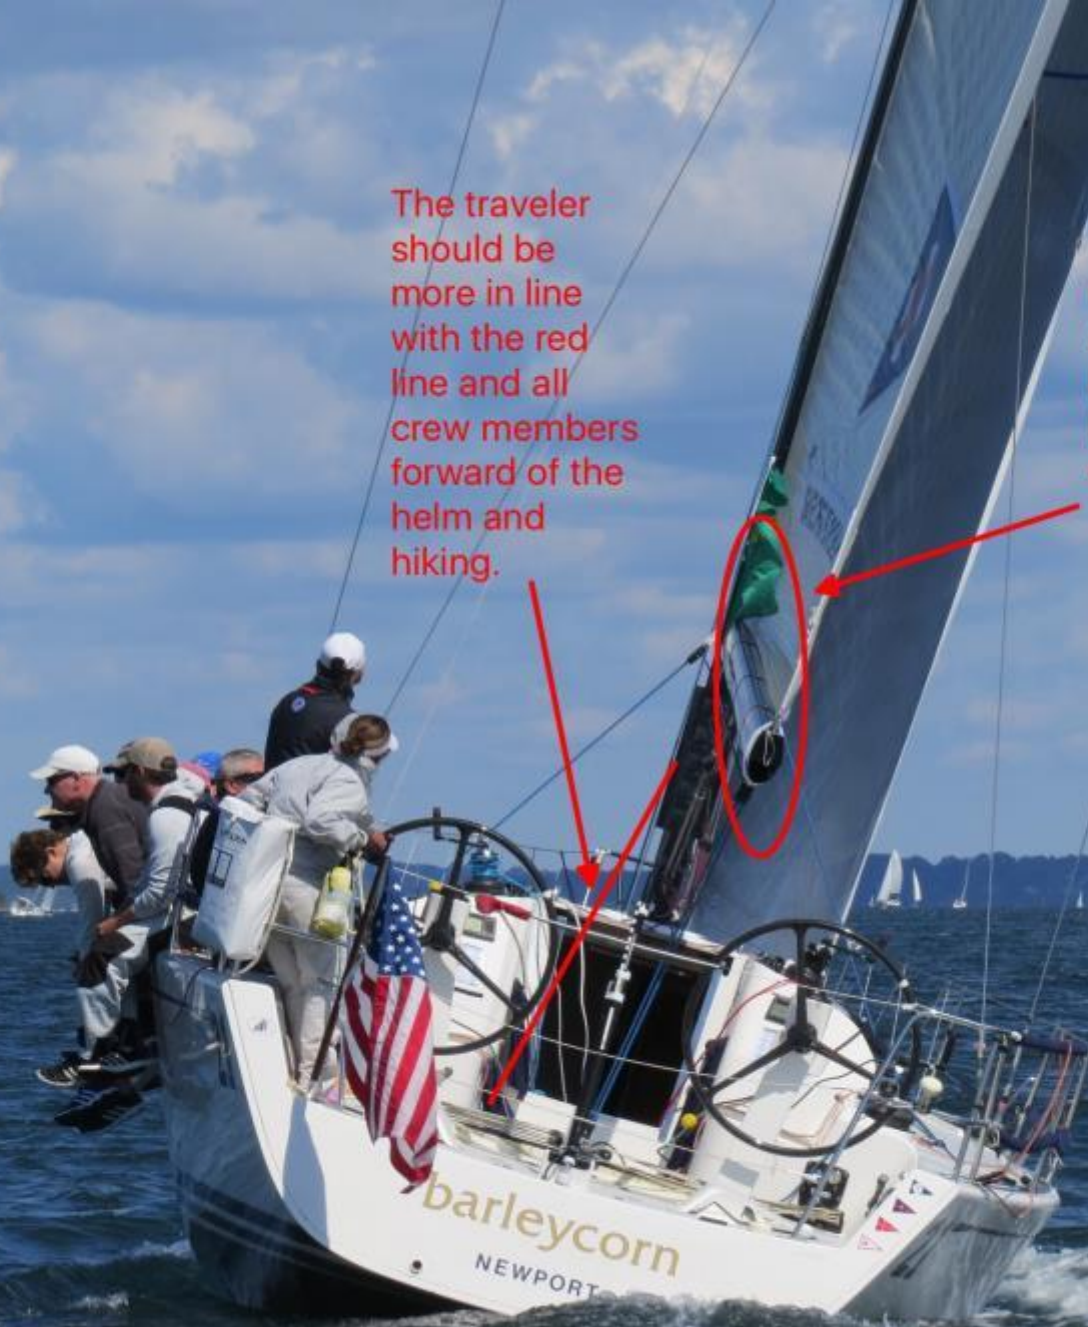
The traveler should be more in line with the red line and all crew members forward of the helm and hiking.

Outhaul looks a bit eased here, flatter lower section would be nice.

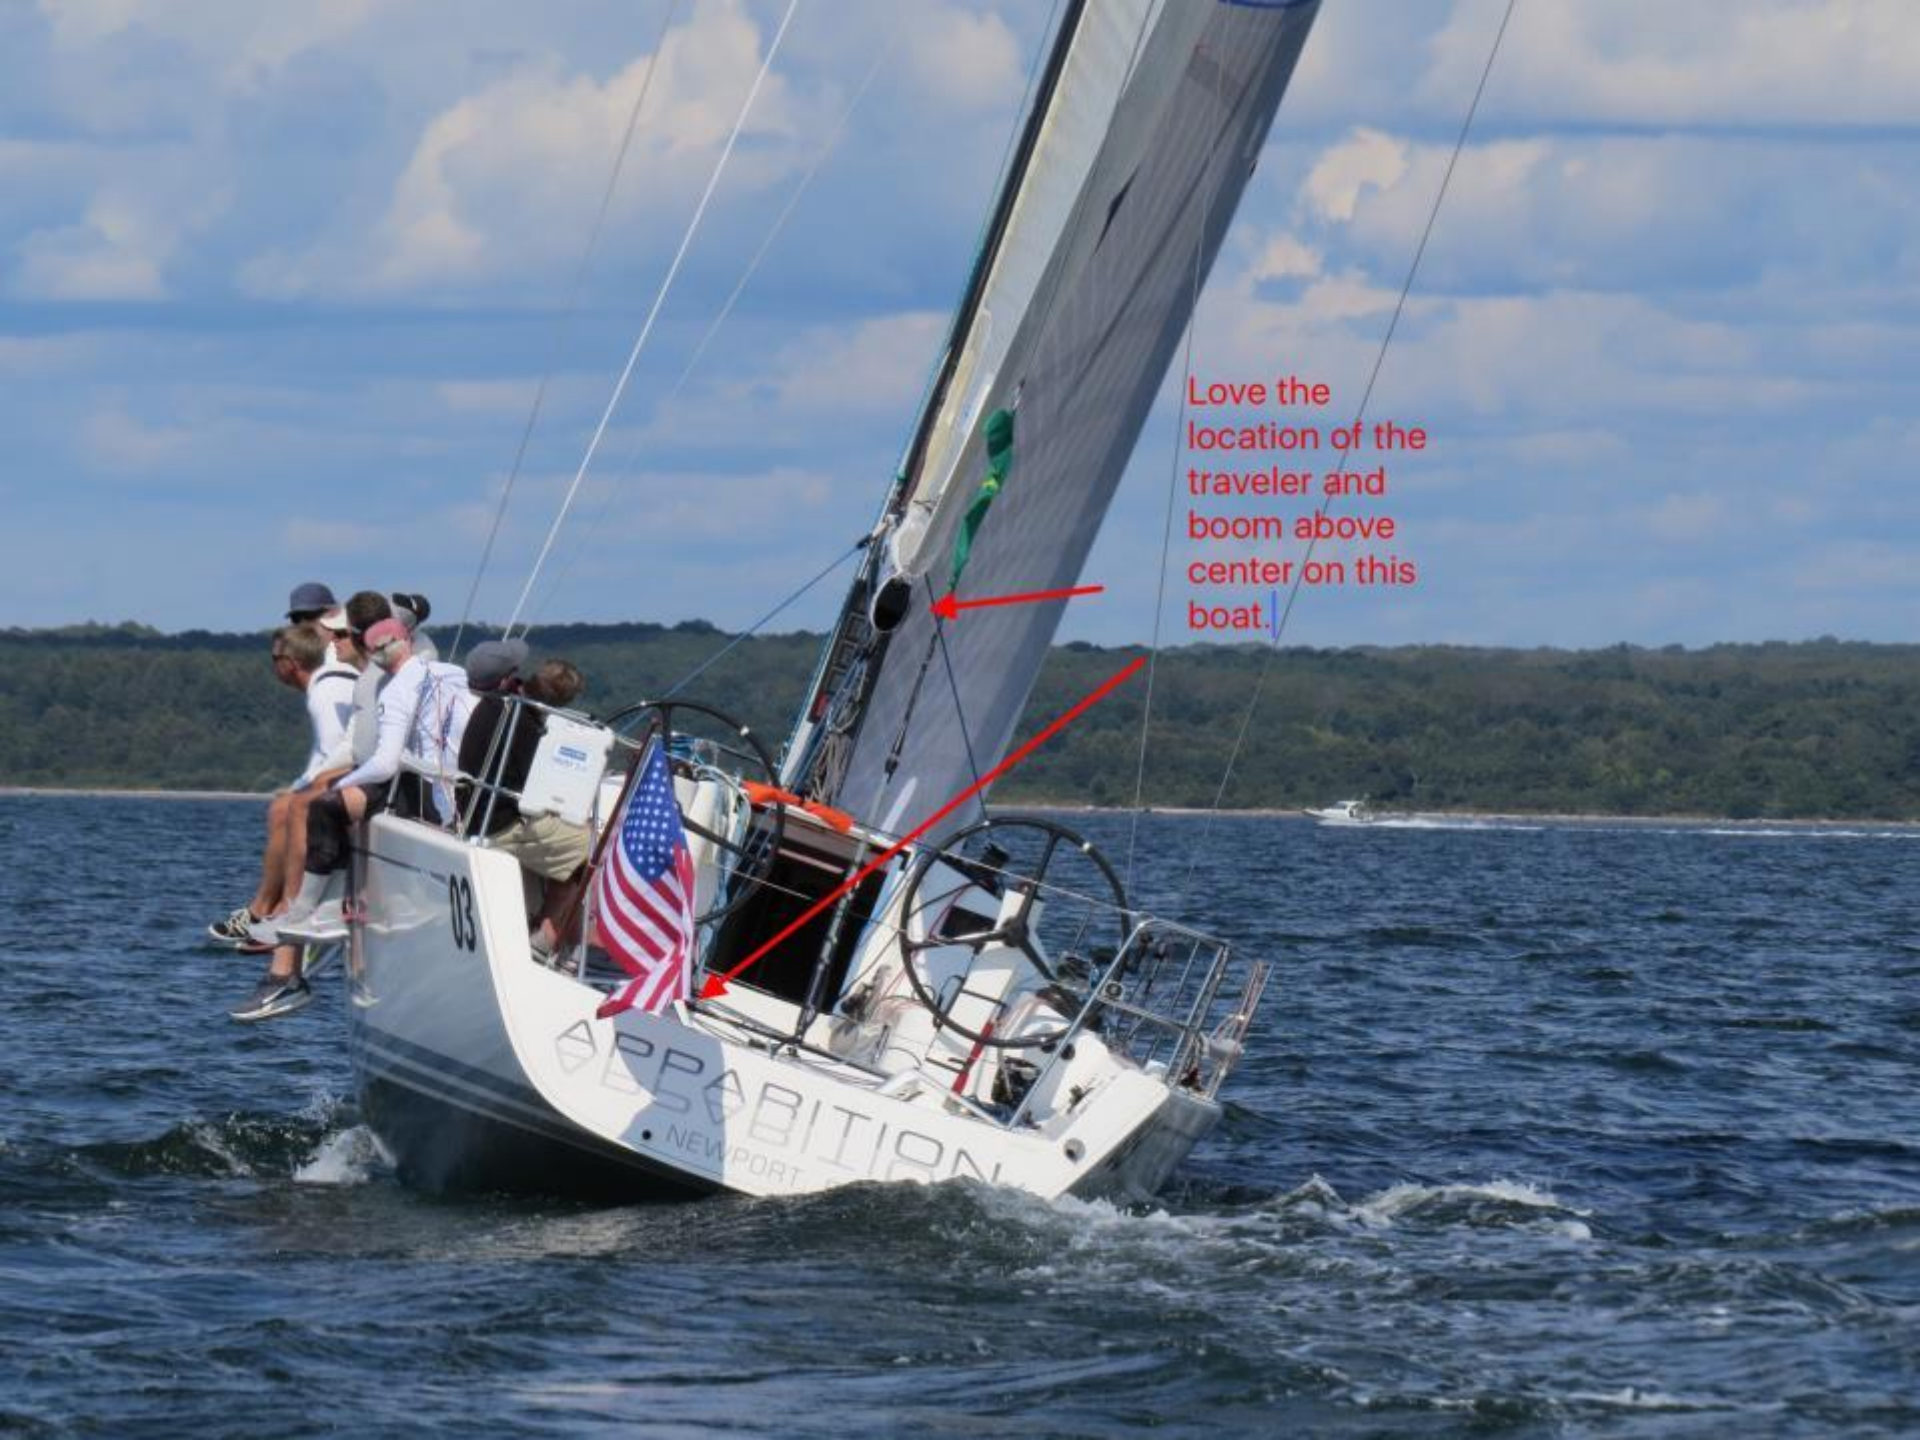
Love the location of the traveler and boom above center on this boat.

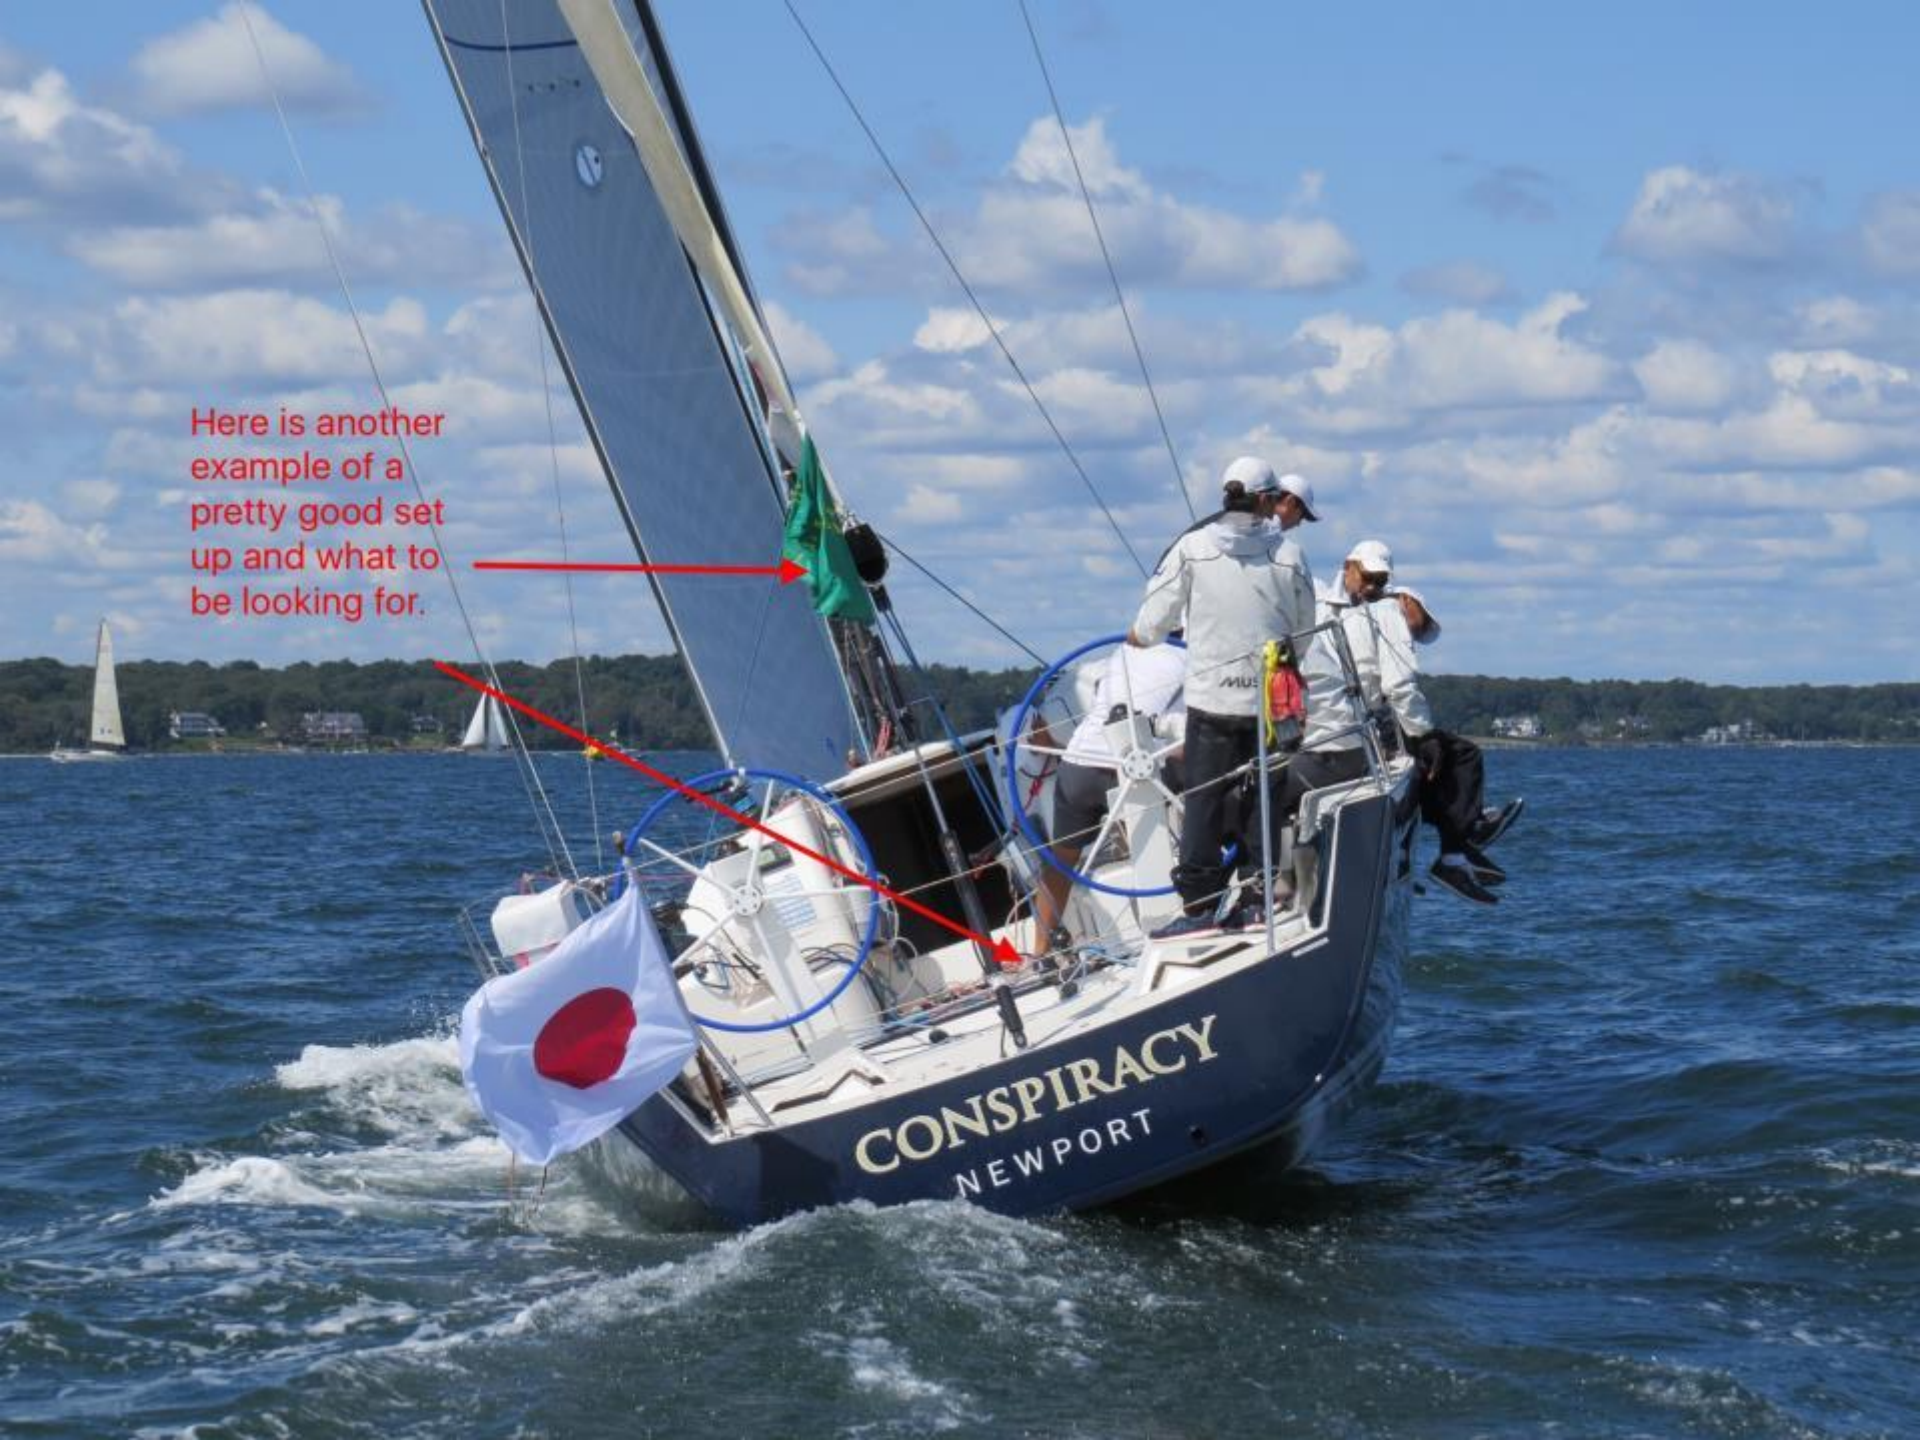
Here is another example of a pretty good set up and what to be looking for.

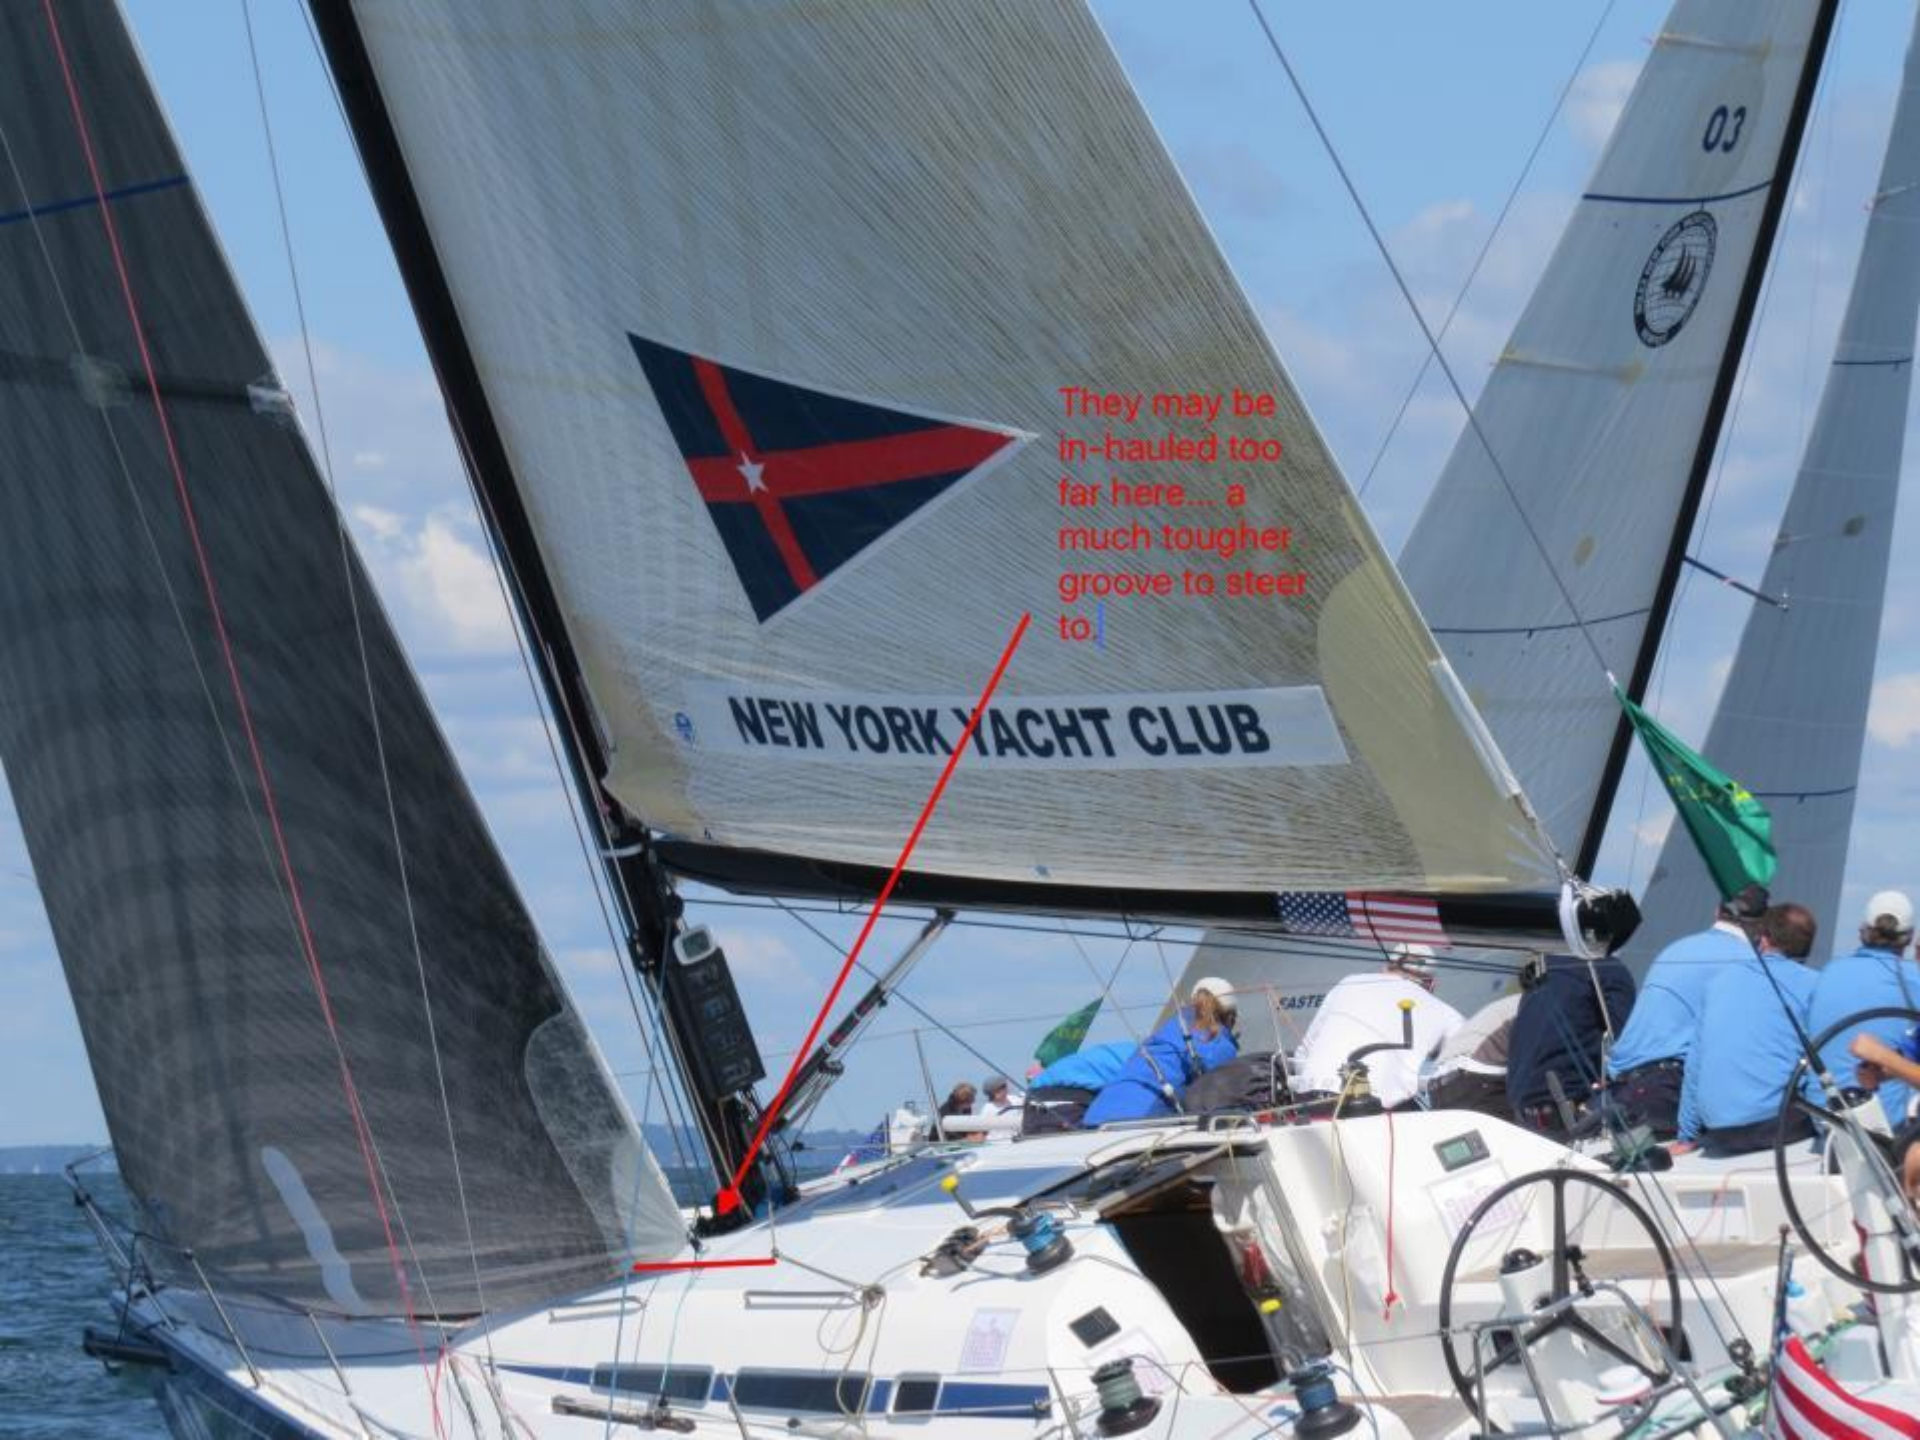
They may be
in-hauled too
far here... a
much tougher
groove to steer
to.
