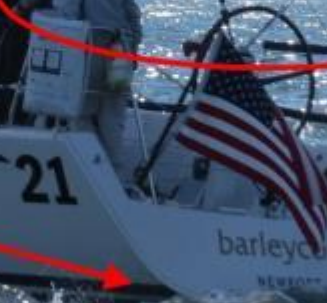
No crew members should ever be aft of the helms person unless it is niking out.

The traveler should be more in line with the red line and all crew members forward of the helm and hiking.

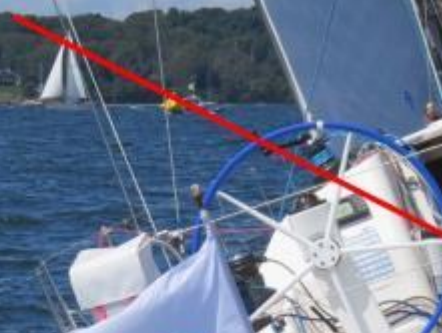
Love the location of the traveler and boom above center on this boat.

Here is another example of a pretty good set up and what to be looking for.
